Manhole Inspection Summary

Manhole # S09Q__001MH

Insp Date: 11/19/08 2:32 PM

Location Address: **3326 Strickland St.**

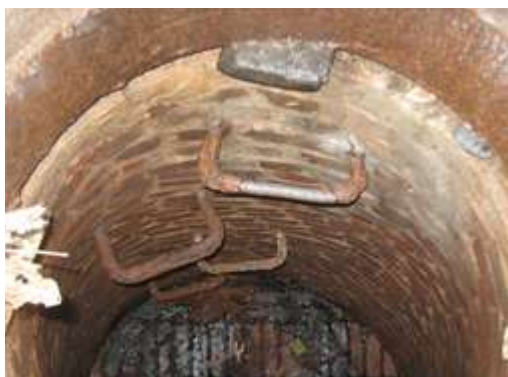
Defect 5

missing mortar and brick at chimney with infiltration and corroded steps

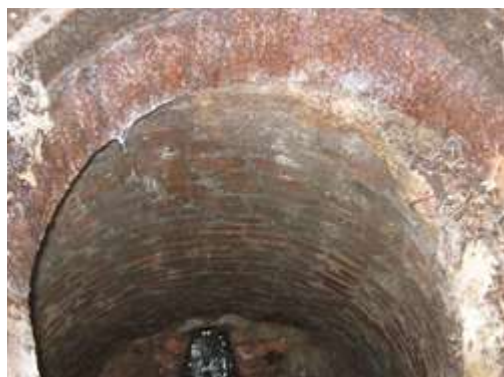
Defect 4

chimney and corbel infiltration and roots at joint

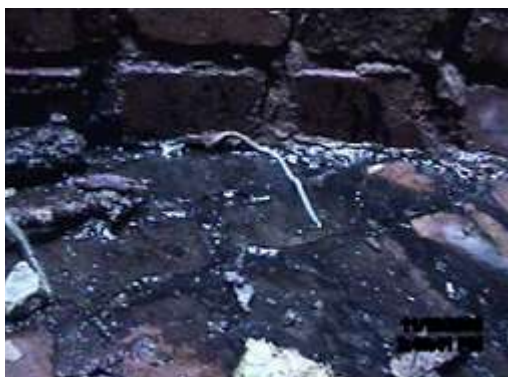
Defect 3

barrel infiltration at bench joint, roots

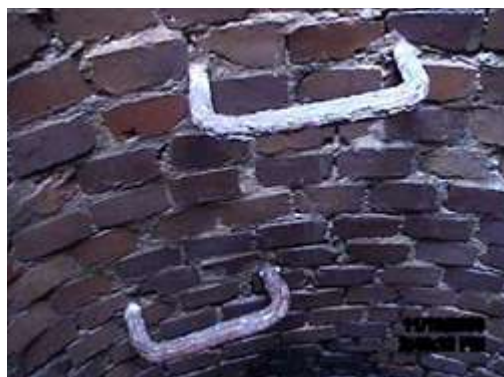
Defect 2

corroded steps

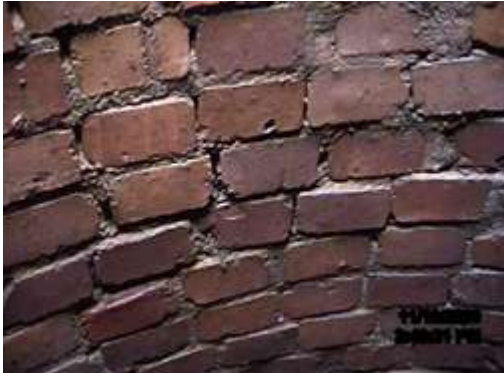
Defect 1

missing mortar at barrel

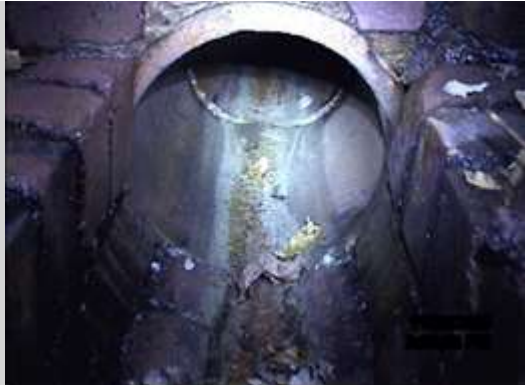
12 O'Clock Outflow

Pipe Height: **8.4** (in.) Rod and Bar (Angled)
Pipe Material: **Clay** ☐ Pipe Lined
Invert Depth: **8.24** (ft.) Flow Characteristics: **Slow**
Deposits: ☒ None ☐ Mud ☐ Sludge ☐ Debris ☐ Grease
Silt Depth: **0** (in.) Deposits Extent:
Infiltration: **Evidence** Pipe Seal Cond: **Unknown**

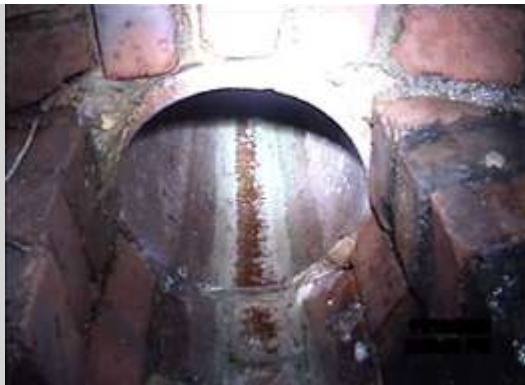
6 O'Clock Inflow

Pipe Height: **8.4** (in.) Rod and Bar (Angled)
Pipe Material: **Clay** ☐ Pipe Lined
Invert Depth: **8.11** (ft.) Flow Characteristics: **Slow**
Deposits: ☒ None ☐ Mud ☐ Sludge ☐ Debris ☐ Grease
Silt Depth: **0** (in.) Deposits Extent:
Infiltration: **Evidence** Pipe Seal Cond: **Unknown**
